CASE REPORT

Management of Severe Polytrauma in a 16-Year-Old Male Involving Cervical Foreign Body (Metal Cap with Barcode): A Multidisciplinary Approach

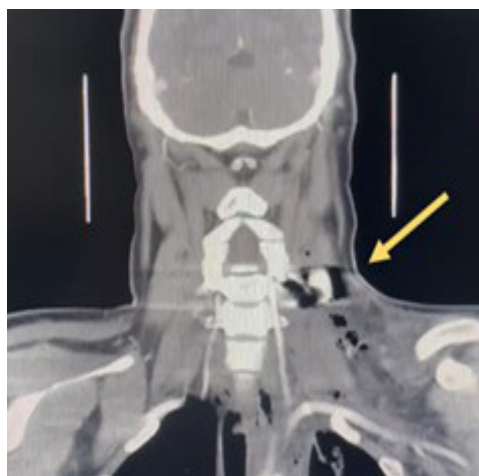
FIGURE 1: Yellow arrow in coronal cut of CECT neck showed hyperdense foreign body measuring 1.8 x 2.8 x 2.5 cm in the left posterior cervical soft tissue at the C5-C6 level

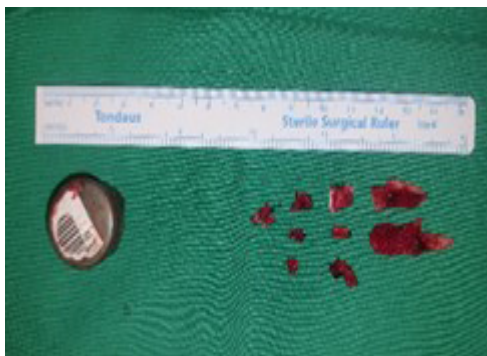
FIGURE 2: This image showed a metal cap and multiple fragments of a clavicle bone that were surgically removed
